Environmental Management Consulting, Inc.

Facility Safety Audit
Platteville School District
October 10, 2005

On September 27, 2005, Todd J. Swenson of Environmental Management Consulting, Inc. (EMC) performed a safety audit of the Platteville School District's Elementary Schools.

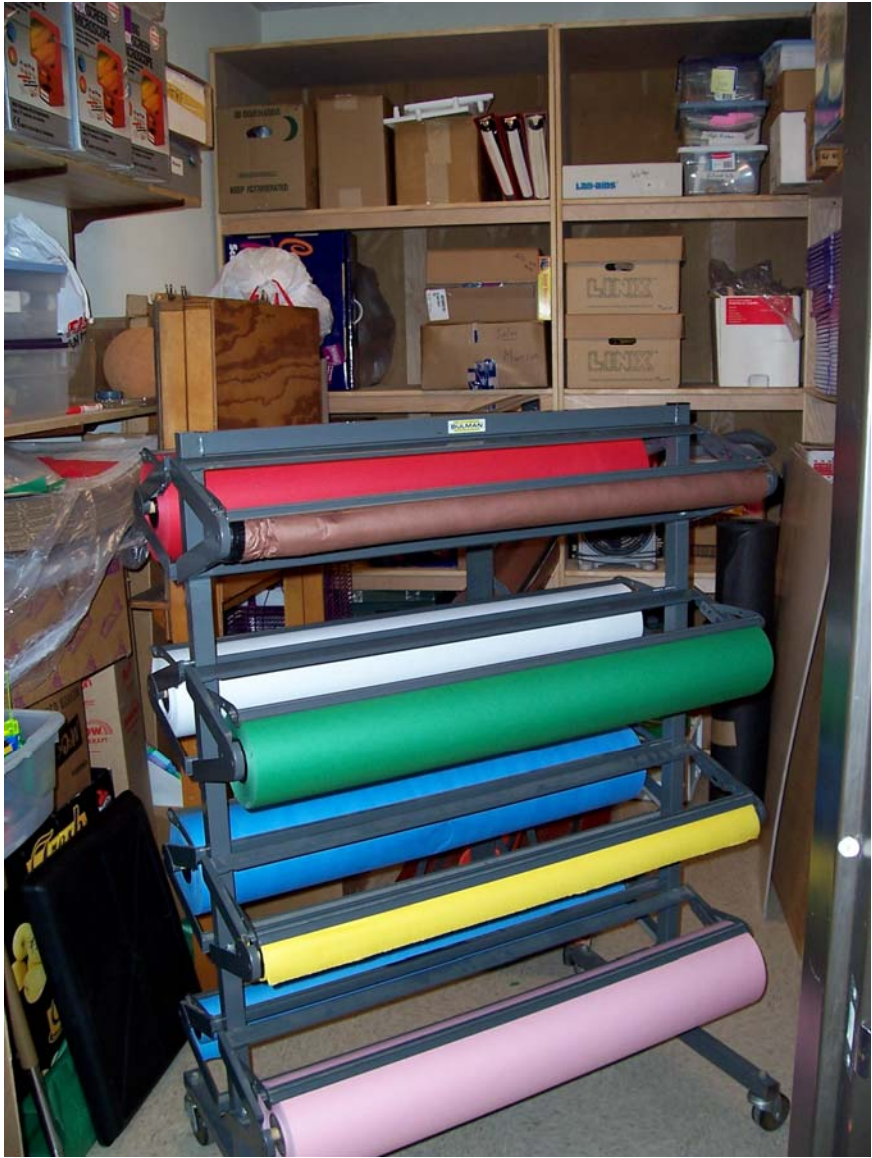
Wilkins Elementary School
Room 17
Photo 1

- General housekeeping.

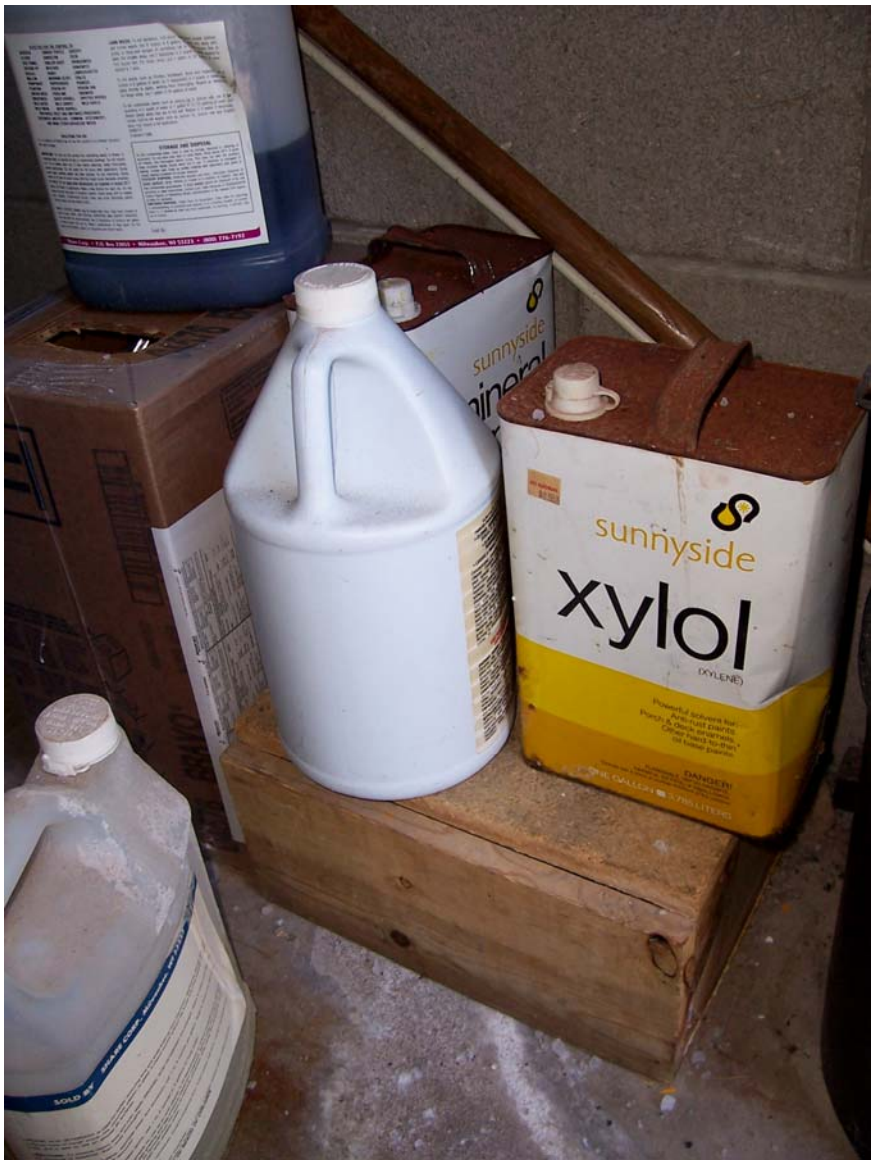
Wilkins Elementary School
Outside Equipment Storage
Photo 2

- Flammable liquids should not be stored with combustibles.

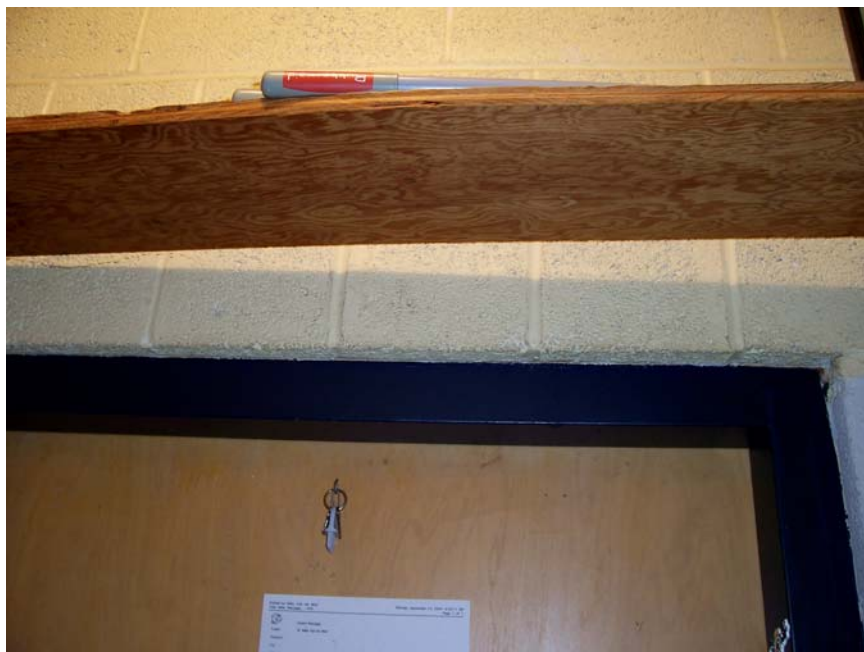
Gray Early Learning Center
Janitor Closet at Office

Photo 3 - Shelf unstable and above doorway. Recommend removing shelf.

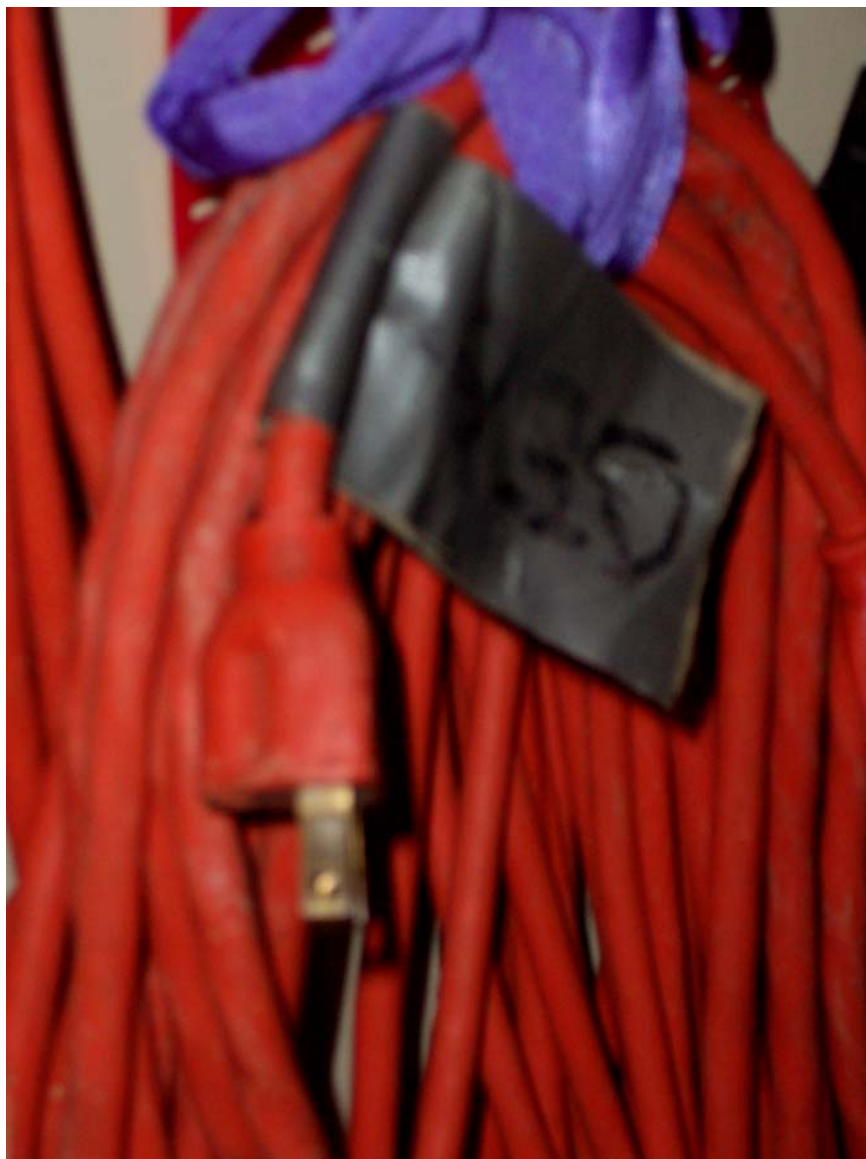
Gray Early Learning Center
Boiler Room

Photo 4 - Ground prong missing on extension cord.

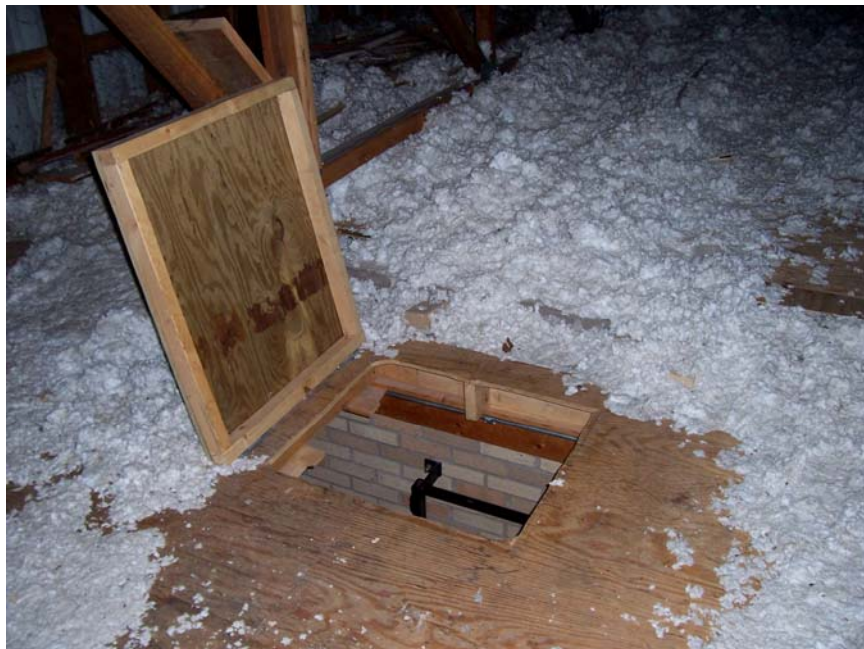
Photo 5

- Fixed ladder extension missing. Fixed ladder should extend 3 ½' above landing.

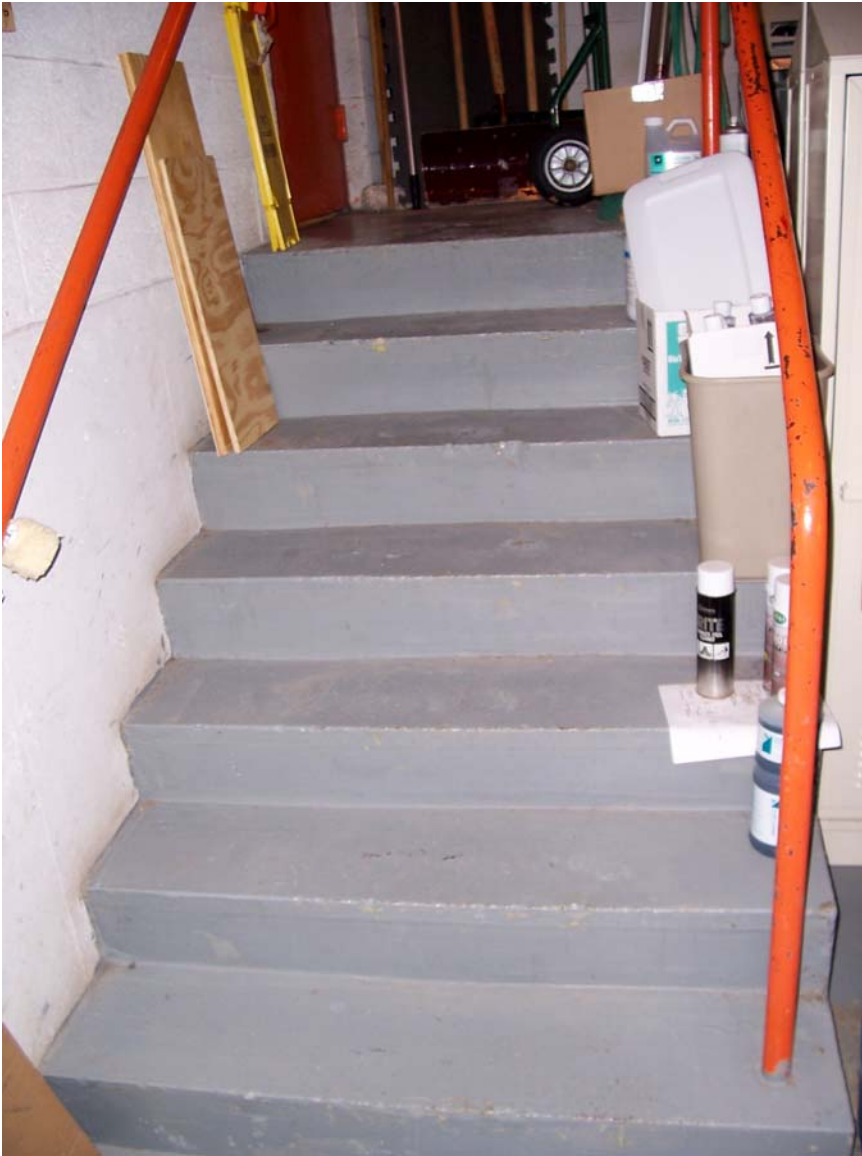
Gray Early Learning Center
Boiler Room
Photo 6

- Non-skid strips required on stairs.

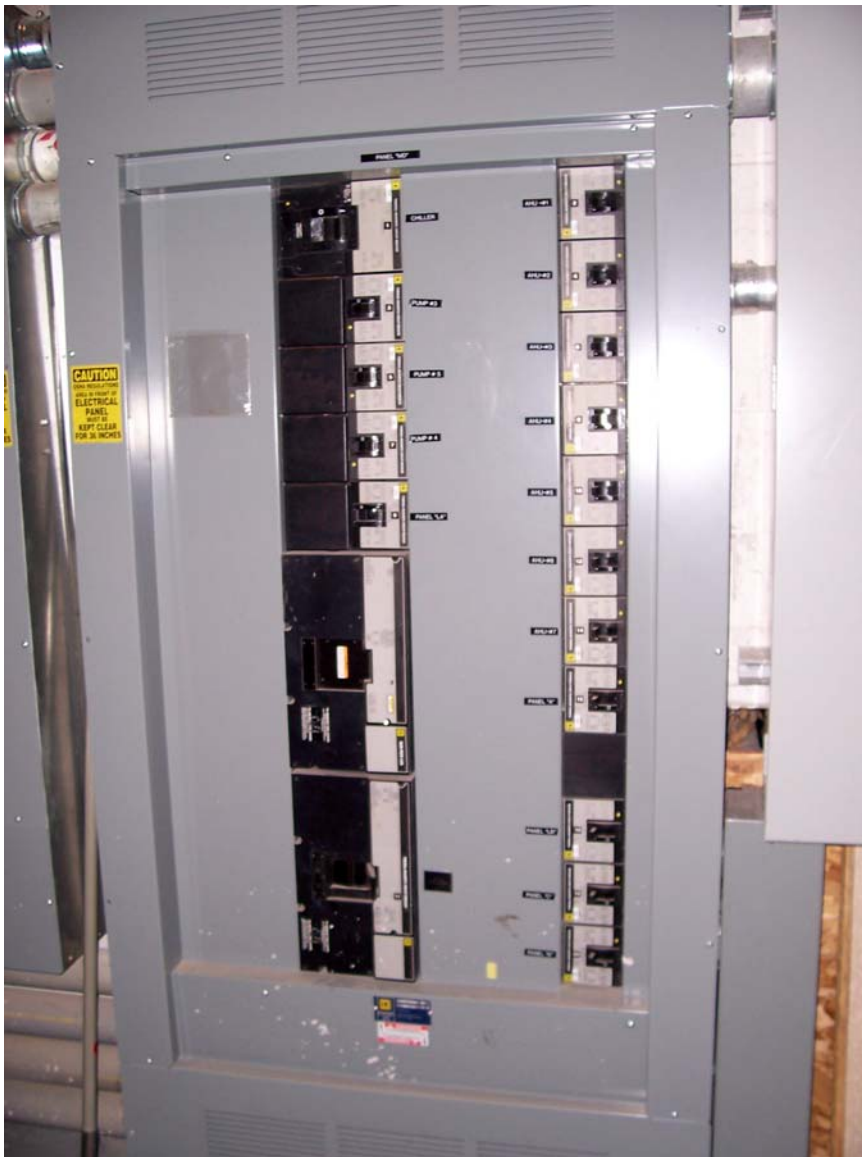
Gray Early Learning Center
Boiler Room
Photo 7

- Electrical panel is missing faceplate.

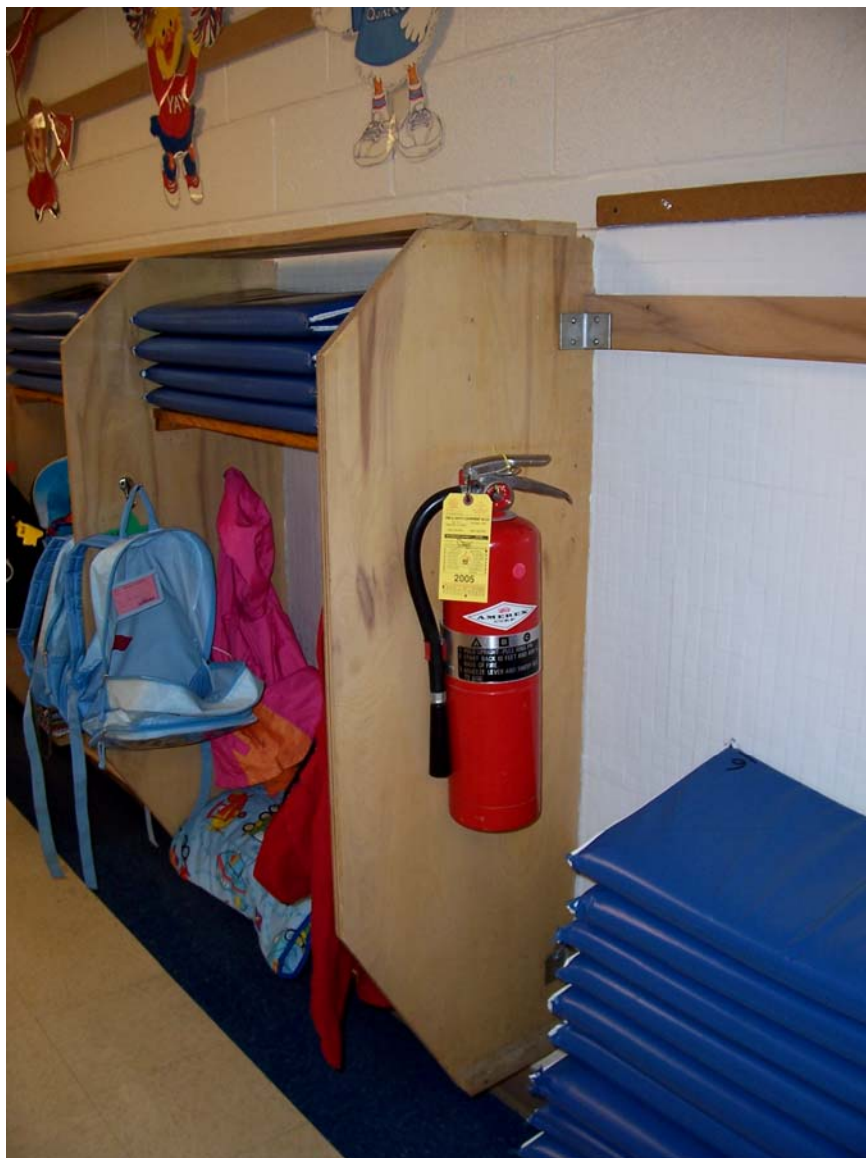
Gray Early Learning Center
Hallway
Photo 8

- Fire extinguisher not properly labeled.
Recommend installing sign on wall above extinguisher.

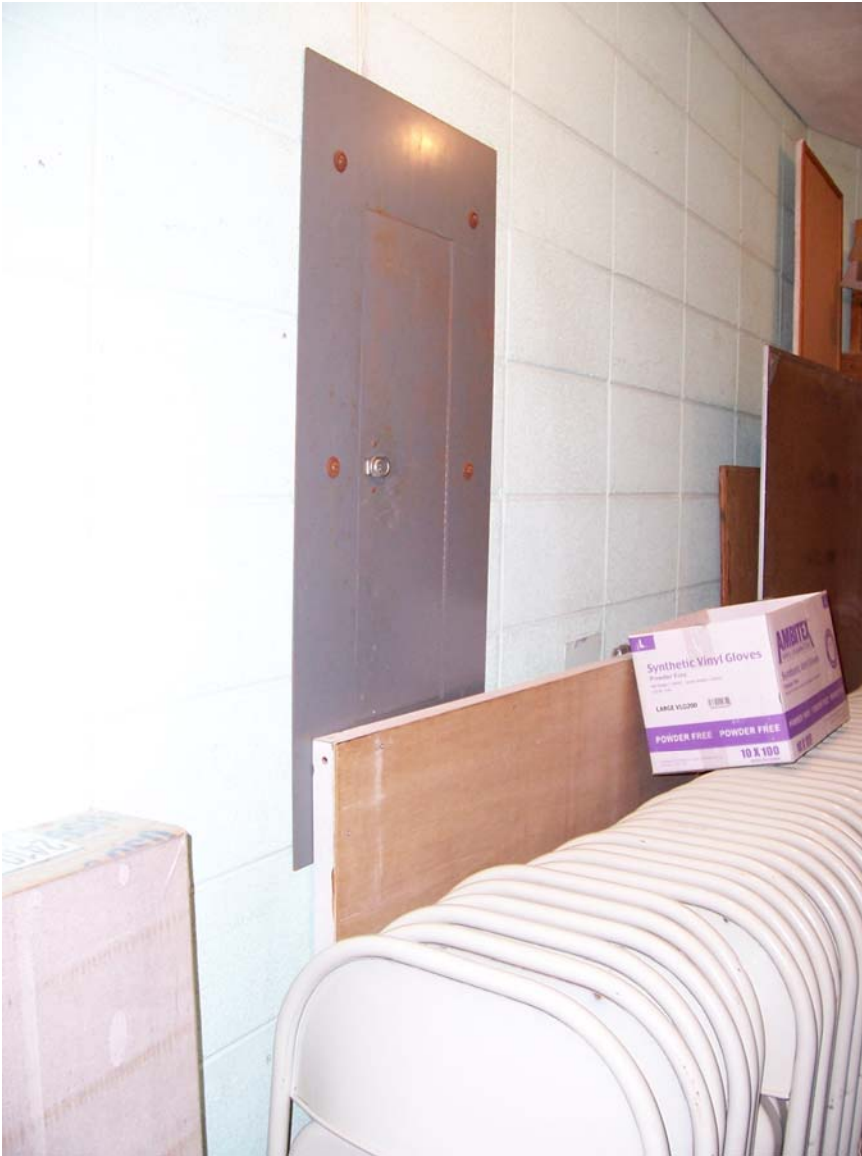
Westview Elementary School
Cust. A
Photo 9

- 3 ft. clearance necessary in front of electrical panels.

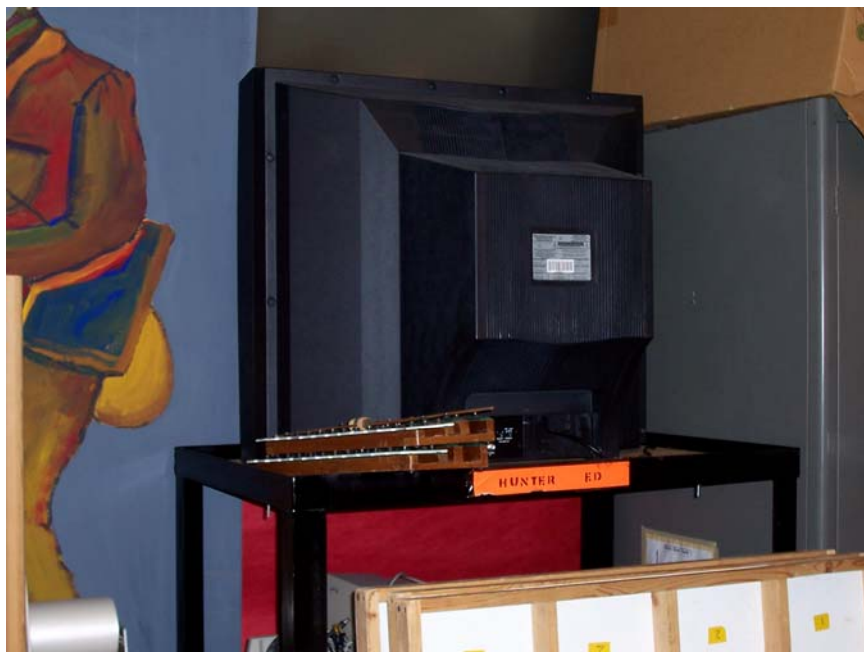
Westview Elementary School
Room 14
Photo 10

- Television must be stabilized and secured to cart.
