**Environmental Management Consulting, Inc.**

Facility Safety Audit  
Platteville School District  
February 28, 2006

On January 18, 2006, Todd J. Swenson of Environmental Management Consulting, Inc. (EMC) performed a safety audit of the Platteville High School and Platteville Middle School.

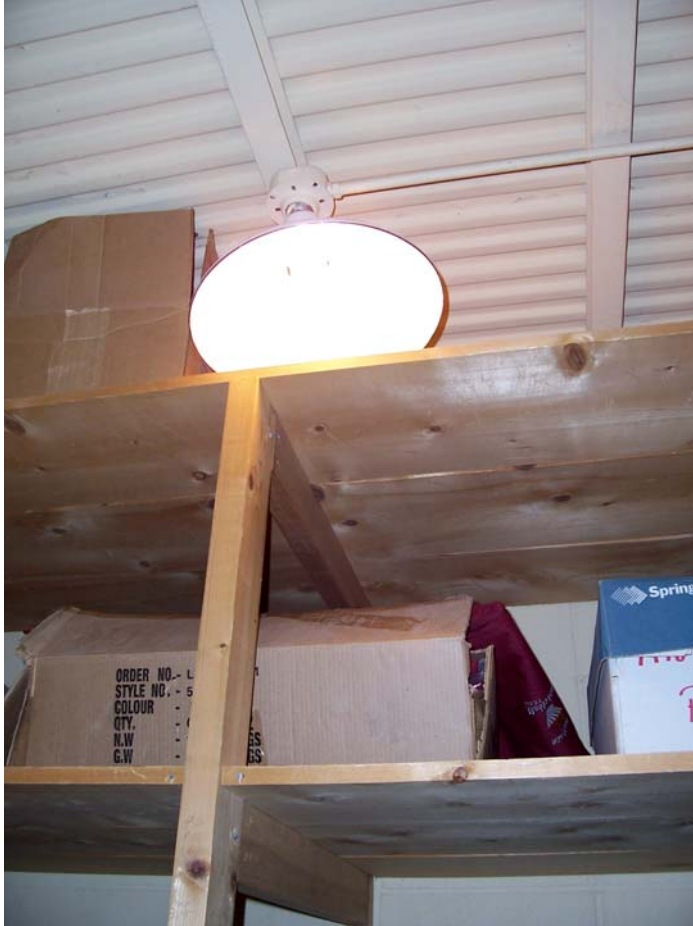
Platteville High School  
Balcony Storage Room 1  
Photo 1

| <u>Location</u> | <u>Description of Deficiency</u> |
|---|--|
| Balcony Storage Room 1 | Combustible cardboard is a potential fire hazard if the light is left on for an extended period of time. Remove combustible material from heat source. (photo 1) |

Combustible cardboard is a potential fire hazard if the light is left on for an extended period of time. Remove combustible material from heat source.

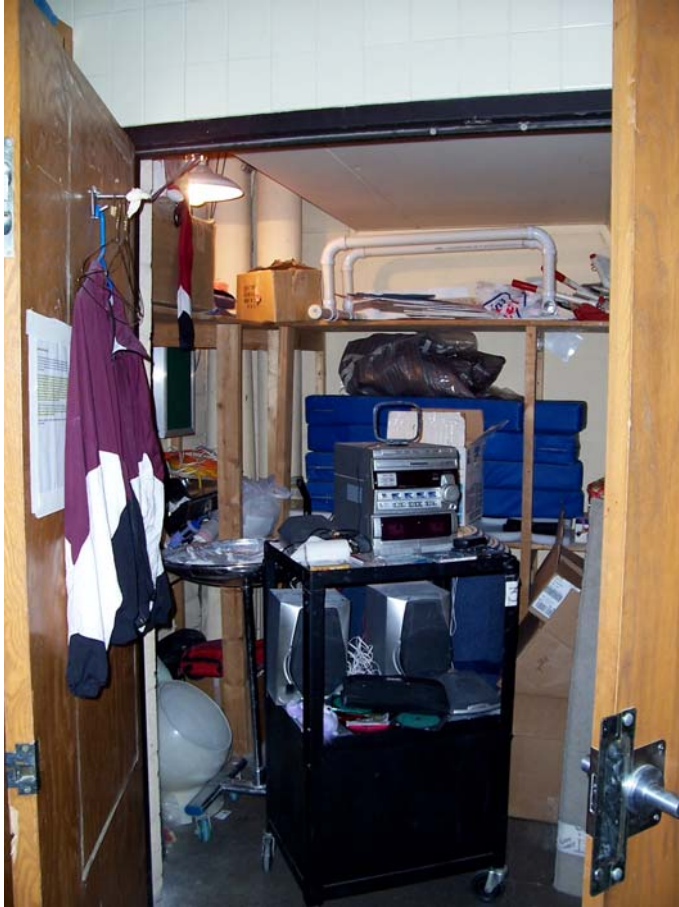
Platteville High School  
Balcony Storage Room 2  
Photo 2

| <u>Location</u> | <u>Description of Deficiency</u> |
|---|--|
| Balcony Storage Room 2 | Combustible cardboard is a potential fire hazard if the light is left on for an extended period of time. Remove combustible material from heat source.<br>General housekeeping.<br>(photo 2) |

- Combustible cardboard is a potential fire hazard if the light is left on for an extended period of time. Remove combustible material from heat source.
- General housekeeping.

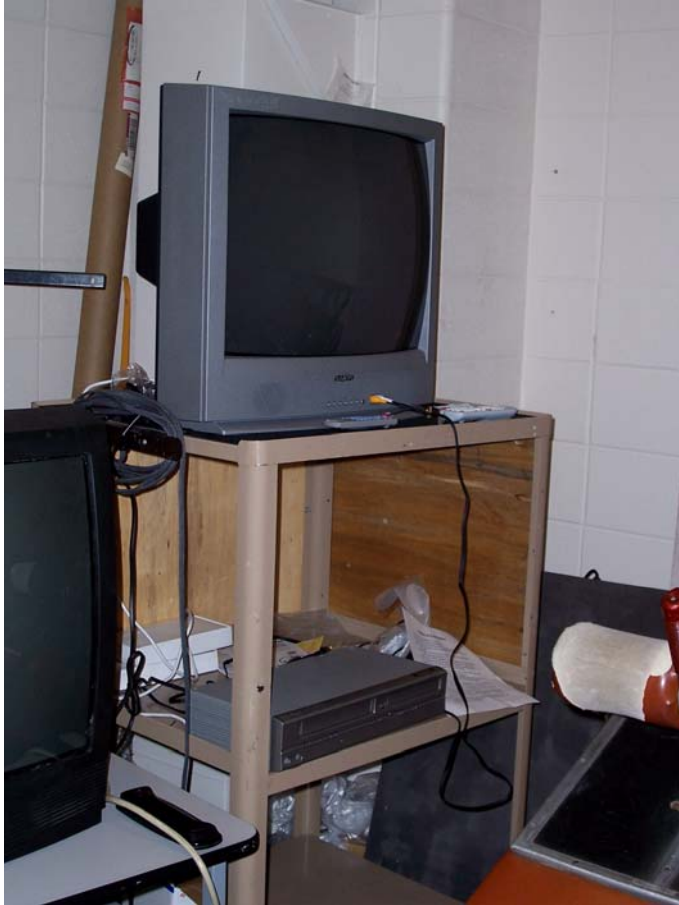
Platteville High School  
Phy. Ed. Storage  
Photo 3

| <u>Location</u> | <u>Description of Deficiency</u> |
|---|--|
| Phy. Ed. Storage | TV not secured to cart. Secure TV to cart to prevent tipping over.<br>(photo 3) |

- TV not secured to cart. Secure TV to cart to prevent tipping over.

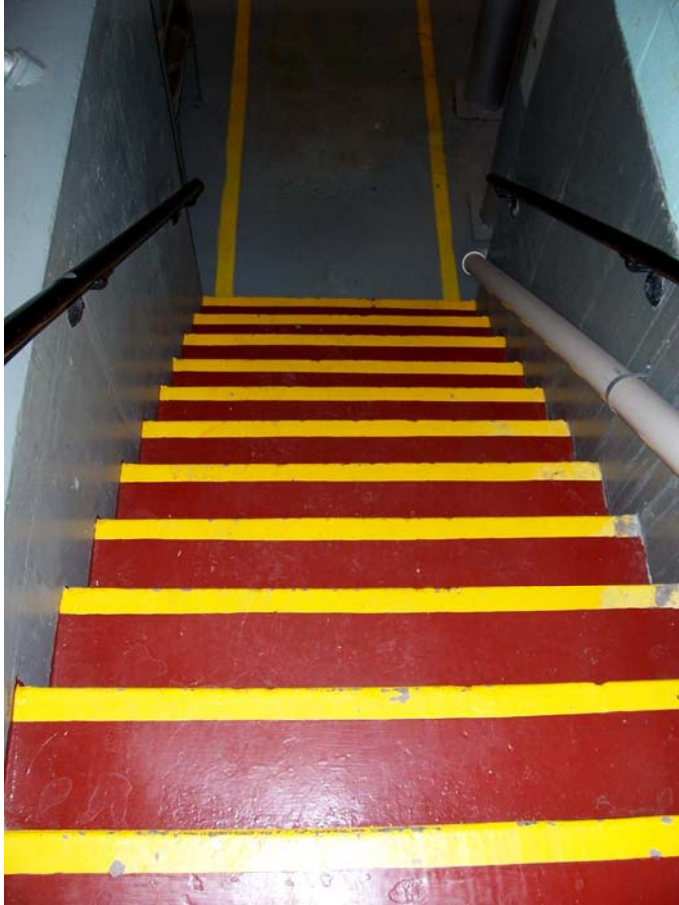
Platteville High School  
Boiler Room  
Photo 4

| <u>Location</u> | <u>Description of Deficiency</u> |
|---|--|
| Boiler Room | Non-skid surface is required on stairs. Applying non-skid strips is recommended. (photo 4) |

- Non-skid surface is required on stairs.  
Applying non-skid strips is recommended.

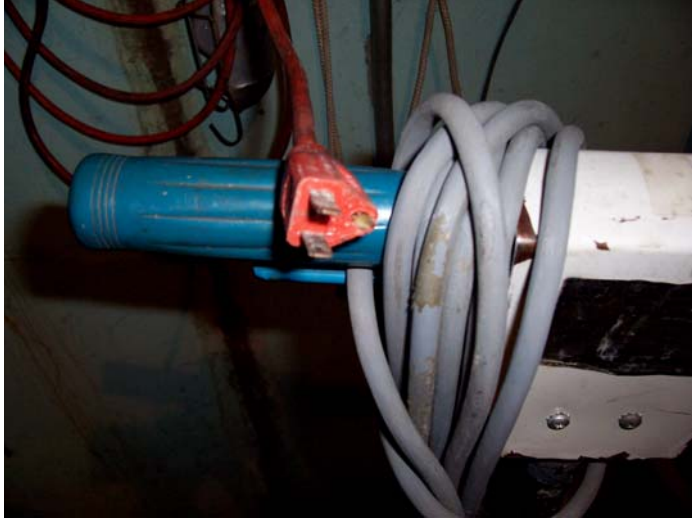
Platteville High School  
Boiler Room  
Photo 5

| <u>Location</u> | <u>Description of Deficiency</u> |
|---|--|
| Boiler Room | Electrical cord is missing ground prongs. Take cord out of service, or replace with grounded plug. (photo 5) |

- Electrical cord is missing ground prongs. Take cord out of service, or replace with grounded plug.

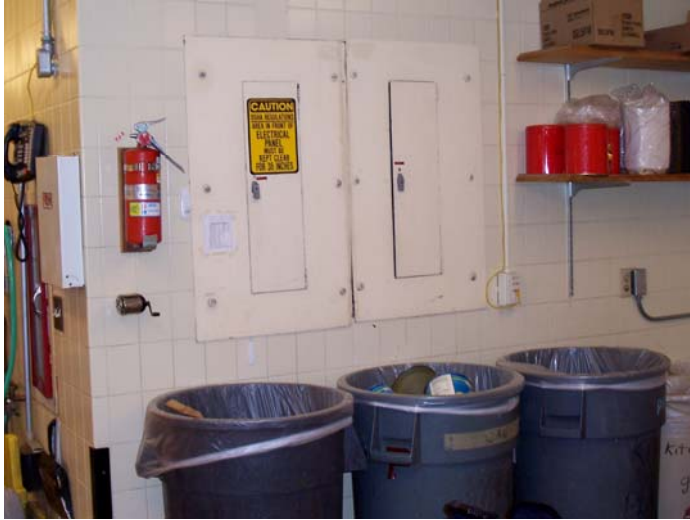
Platteville High School  
Kitchen  
Photo 6

| <u>Location</u> | <u>Description of Deficiency</u> |
|---|--|
| Kitchen | 36" clearance required at electric panels. (photo 6) |

- 3 ft. clearance necessary in front of electrical panels.

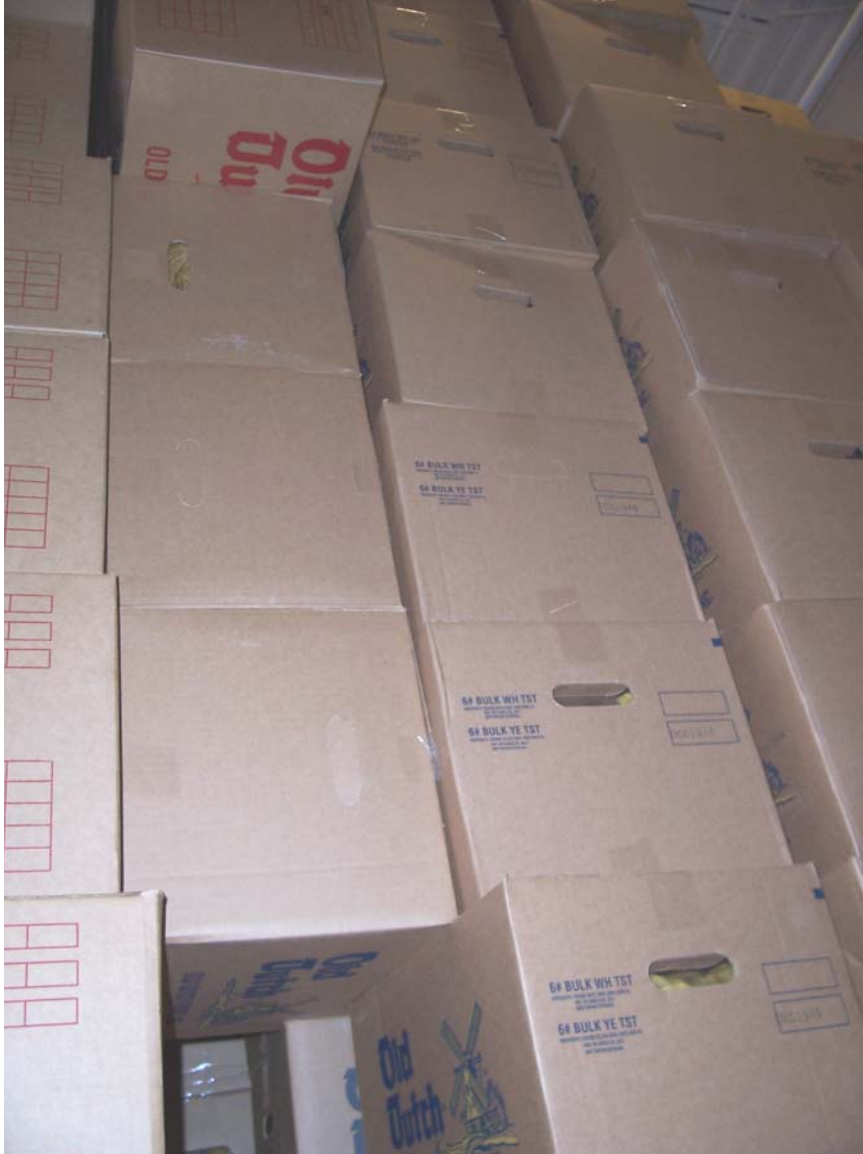
Platteville High School  
New Gym Storage  
Photo 7

| <u>Location</u> | <u>Description of Deficiency</u> |
|---|--|
| New Gym Storage | Unsafe storage of boxes. Ensure stored items are secure to prevent chance of collapse. (photo 7) |

- Unsafe storage of boxes. Ensure stored items are secure to prevent chance of collapse.

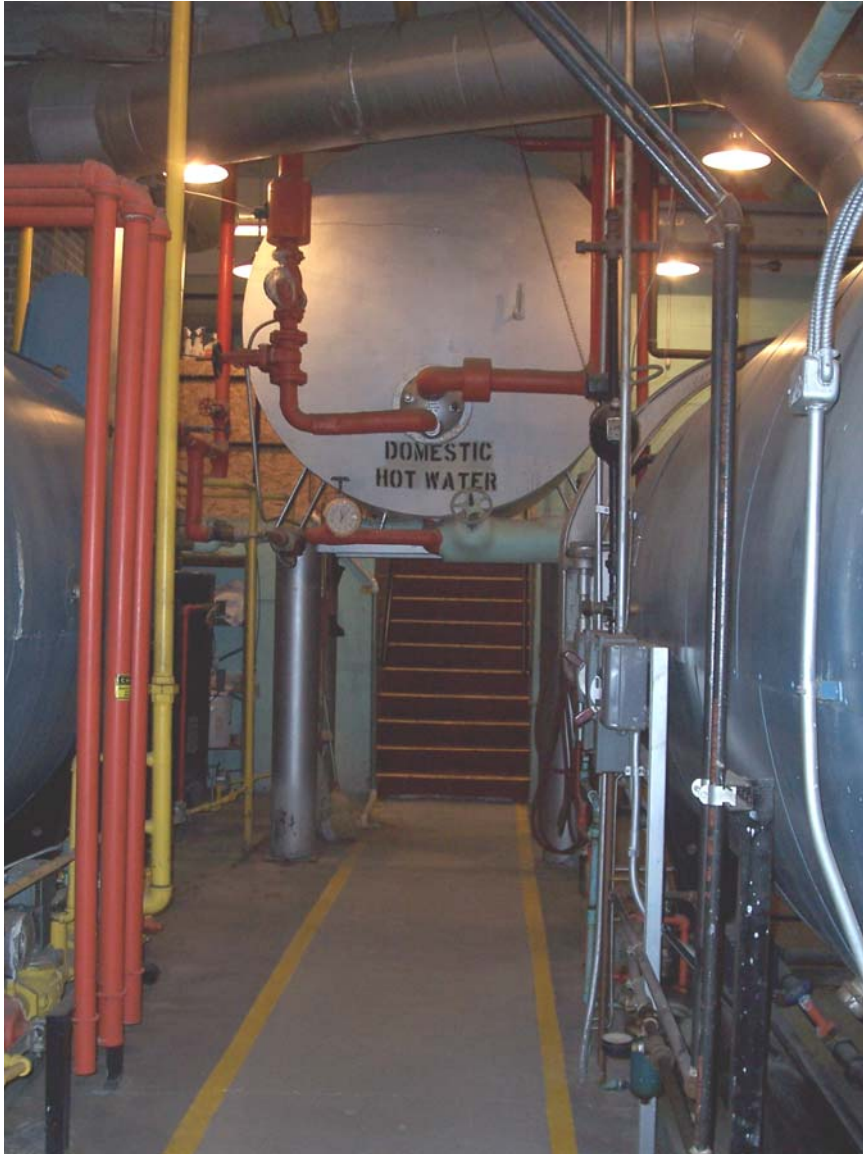
Platteville High School  
Boiler Room  
Photo 8

| <u>Location</u> | <u>Description of Deficiency</u> |
|---|--|
| Boiler Room | No exit signage or evacuation routes posted. Install exit signs that illuminate a minimum of 5 foot candles. Post emergency egress routes. (photos 8 and 9) |

- No exit signage or evacuation routes posted. Install exit signs that illuminate a minimum of 5 foot candles. Post emergency egress routes.

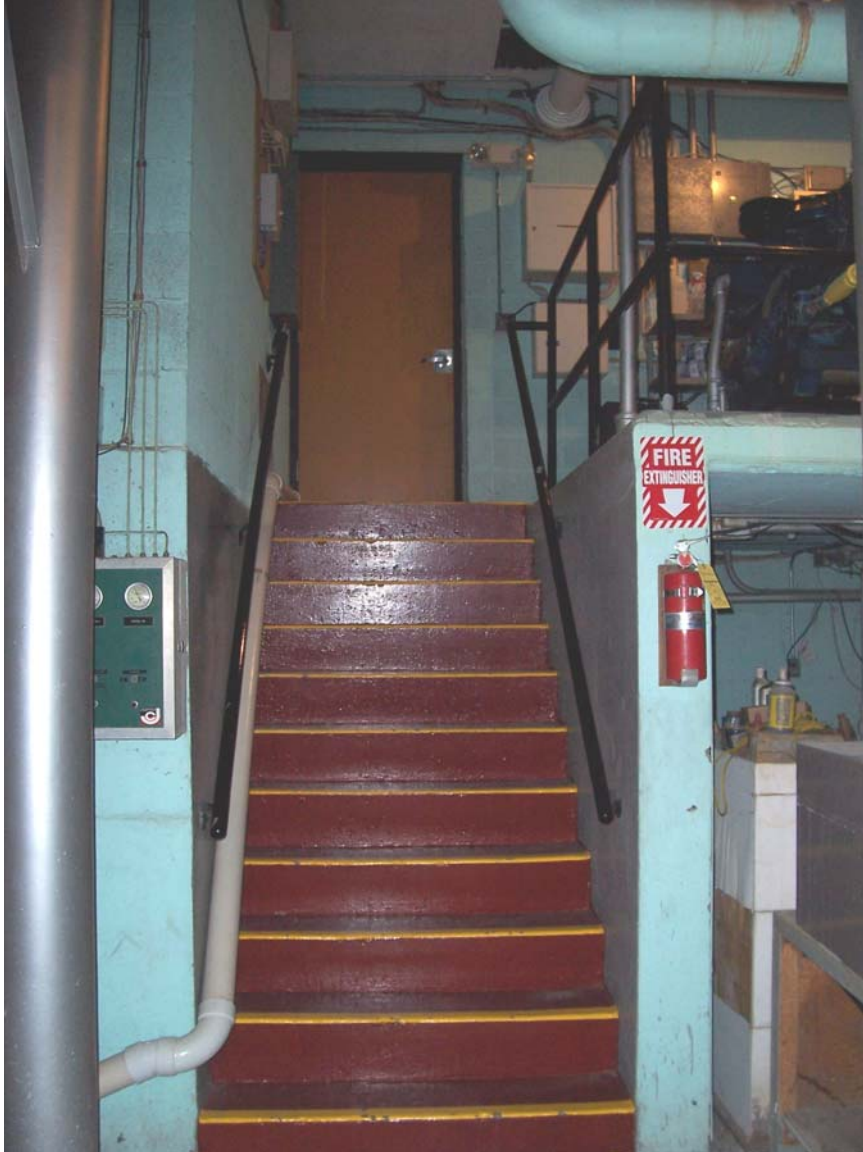
Platteville High School  
Boiler Room  
Photo 9

- No exit signage or evacuation routes posted. Install exit signs that illuminate a minimum of 5 foot candles. Post emergency egress routes.

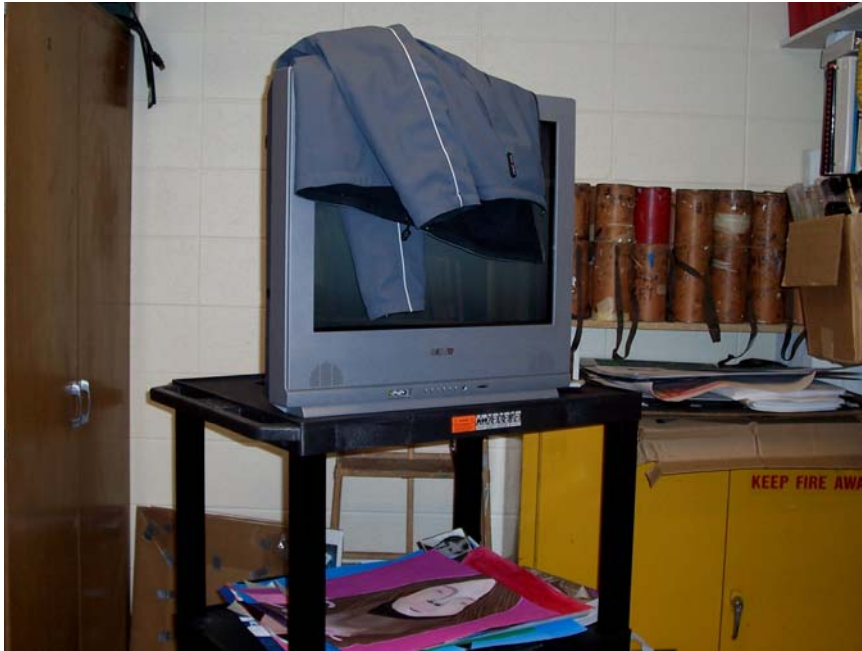
Platteville High School  
Art Storage Room  
Photo 10

| <u>Location</u> | <u>Description of Deficiency</u> |
|---|--|
| Art Storage Room | TV not secured to cart. Secure TV to cart to prevent tipping over. (photo 10) |

- TV not secured to cart. Secure TV to cart to prevent tipping over.

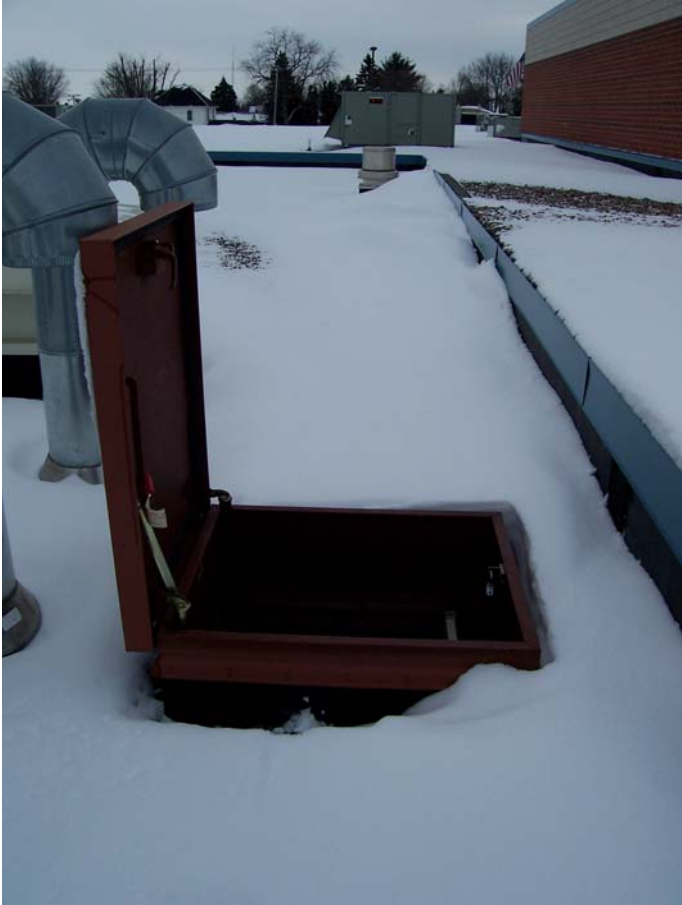
Photo 11

| <u>Location</u> | <u>Description of Deficiency</u> |
|---|--|
| All Roof Access | Fixed ladder extensions missing. Extension should rise above landing 3 ½'. (photo 11) |

- Fixed ladder extensions missing.

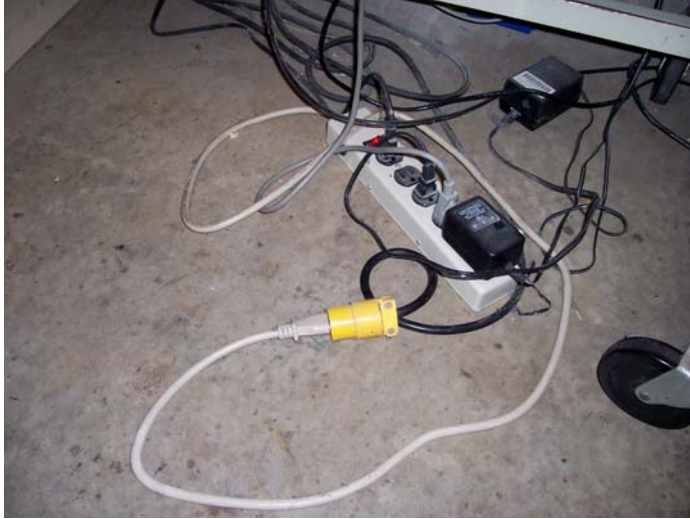
Platteville Middle School  
Room 004  
Photo 12

| <u>Location</u> | <u>Description of Deficiency</u> |
|---|--|
| Room 004 | Multiple extension cords or extension cords and power strips are not to be used together. (photo 12) |

- Multiple extension cords or extension cords and power strips are not to be used together.

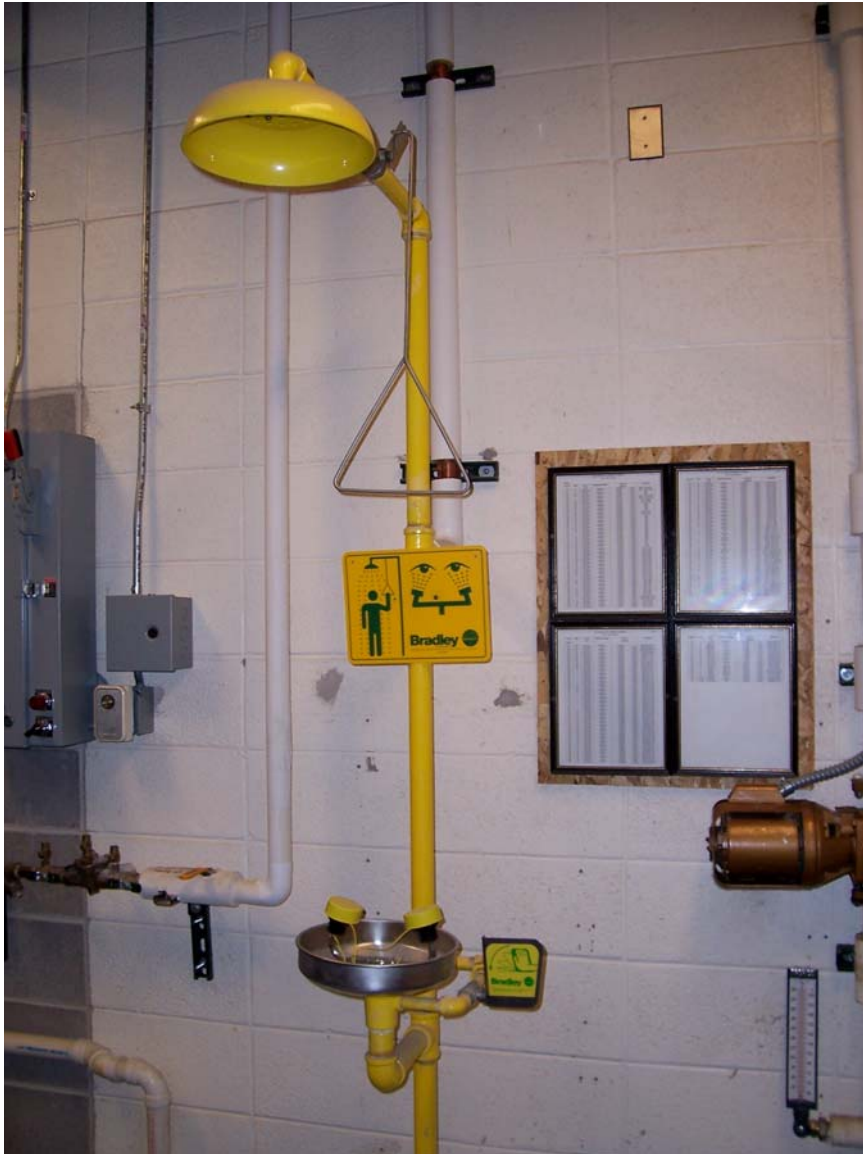
Platteville Middle School  
Kitchen  
Photo 13

| <u>Location</u> | <u>Description of Deficiency</u> |
|---|--|
| Boiler Room 138 | Eyewash and safety shower are not activated weekly and documented. (photo 13) |

- Eyewash and safety shower are not activated weekly and documented.
